# The Architecture

# Embankments

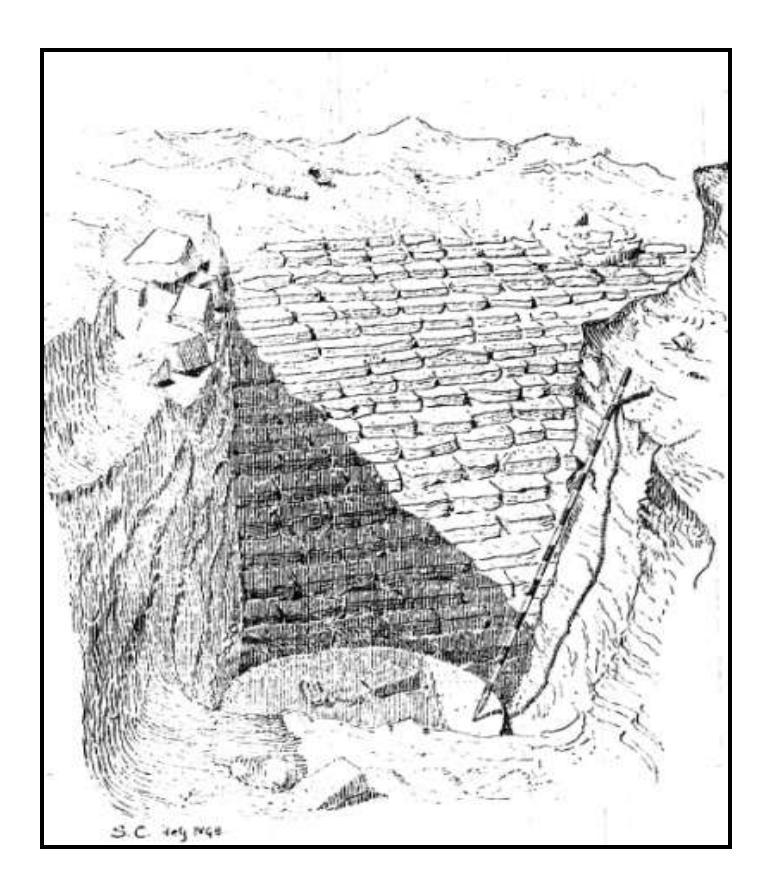
The early dynastic revetment at Hieraconpolis

A preliminary examination of the embankment shows that the method of construction is similar to the revetment of the archaic temple of Hieraconpolis,<sup>3</sup> the fourth Dynasty dam at Wadi Garawi<sup>4</sup> and the revetment of the terrace of the sun temple of Nyuserra.<sup>5</sup>

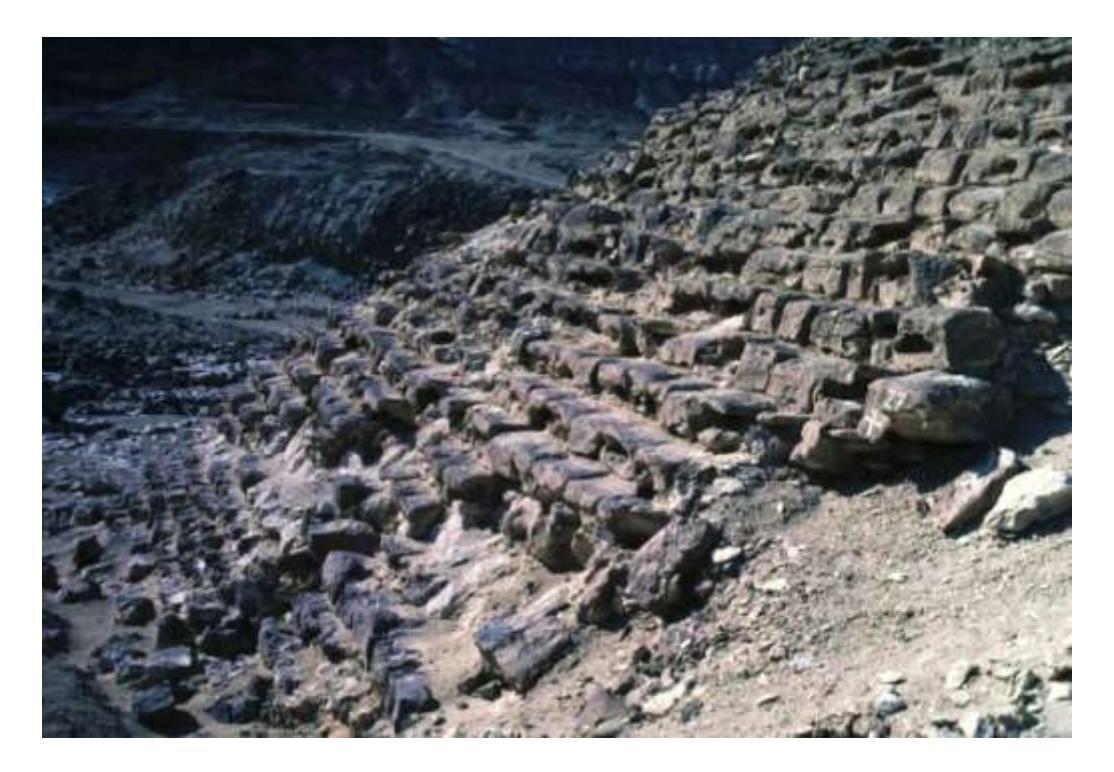
# The dam at wadi Garawi

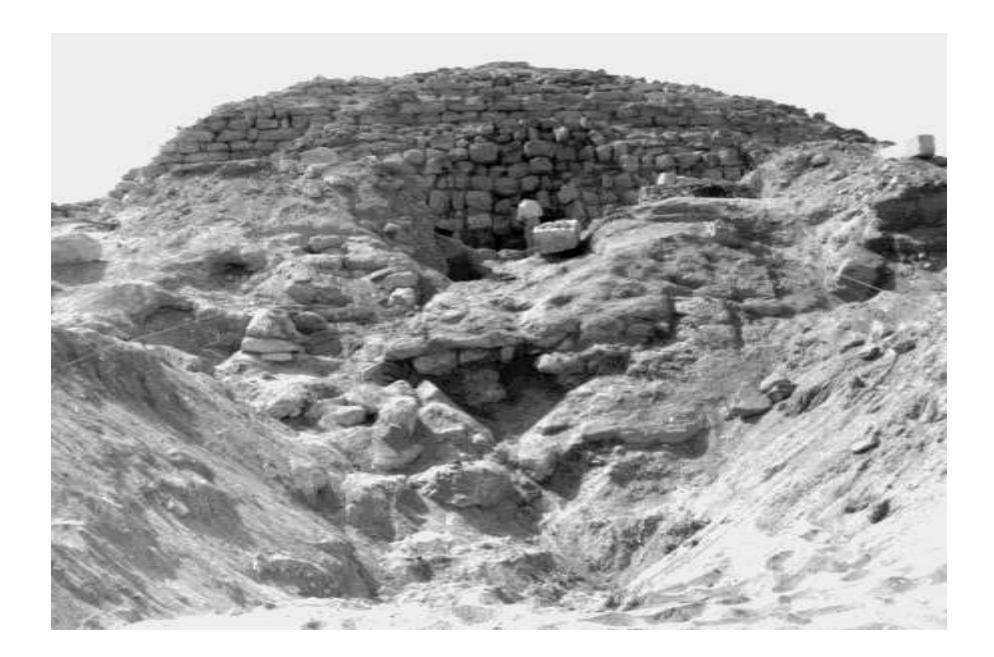
The exposed embankment east of the chapel at Seila

Originally the eastern wadi facing the pyramid of Meidum was too close to the outer facing and there was no space for the east chapel. To overcome this difficulty, a stone embankment with a filling was built across the wadi to create a terrace. The sloping angle of the embankment discovered was 28-30° downwards. There was some trimming of the Pliocene conglomerate, to agree with this slope, 7.5 meters east of the foundation edge and 2 meters north of the axis. West of the trimming some brickwork was unearthed, four stretchers ran north south and three stretchers at right angles the south end.

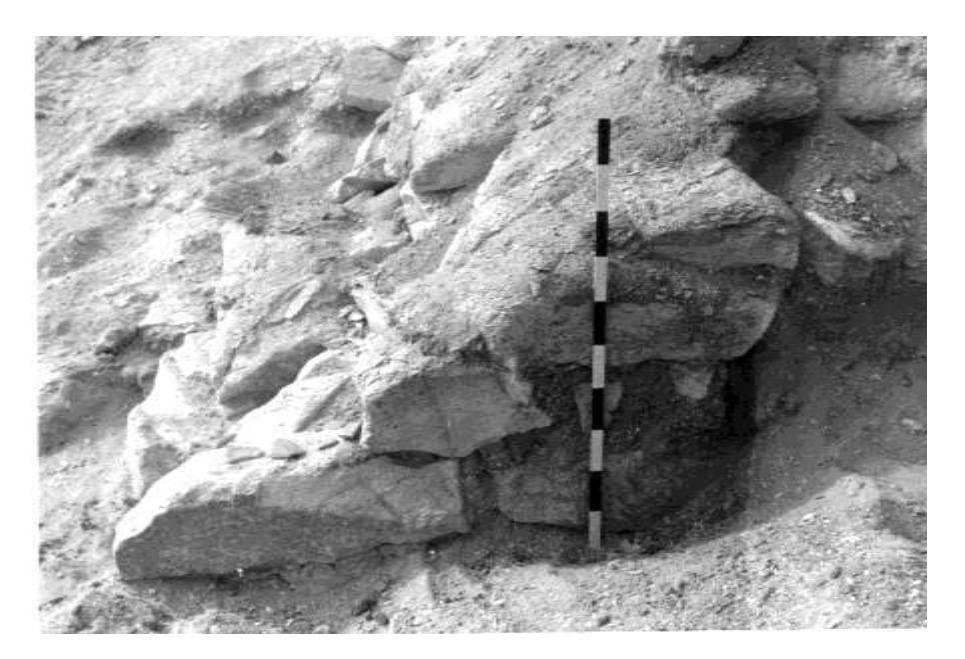
A section in the masonry of the embankment

It is hard to tell at present how the sides of the embankment masonry and the conglomerate joined and what material was used for the final facing which covered

the embankment in the middle and the limestone chipping on the sides, moreover we need to check a possibility of a stairway.

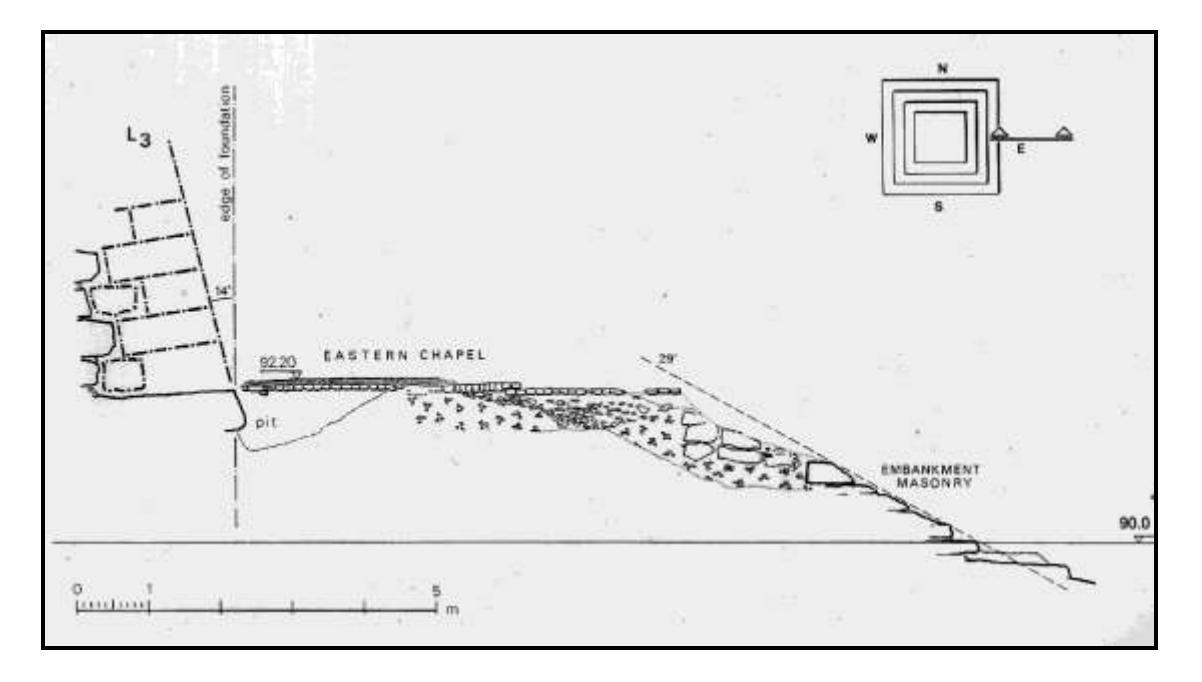
A profile of the eastern embankment and the chapel platform at Seila

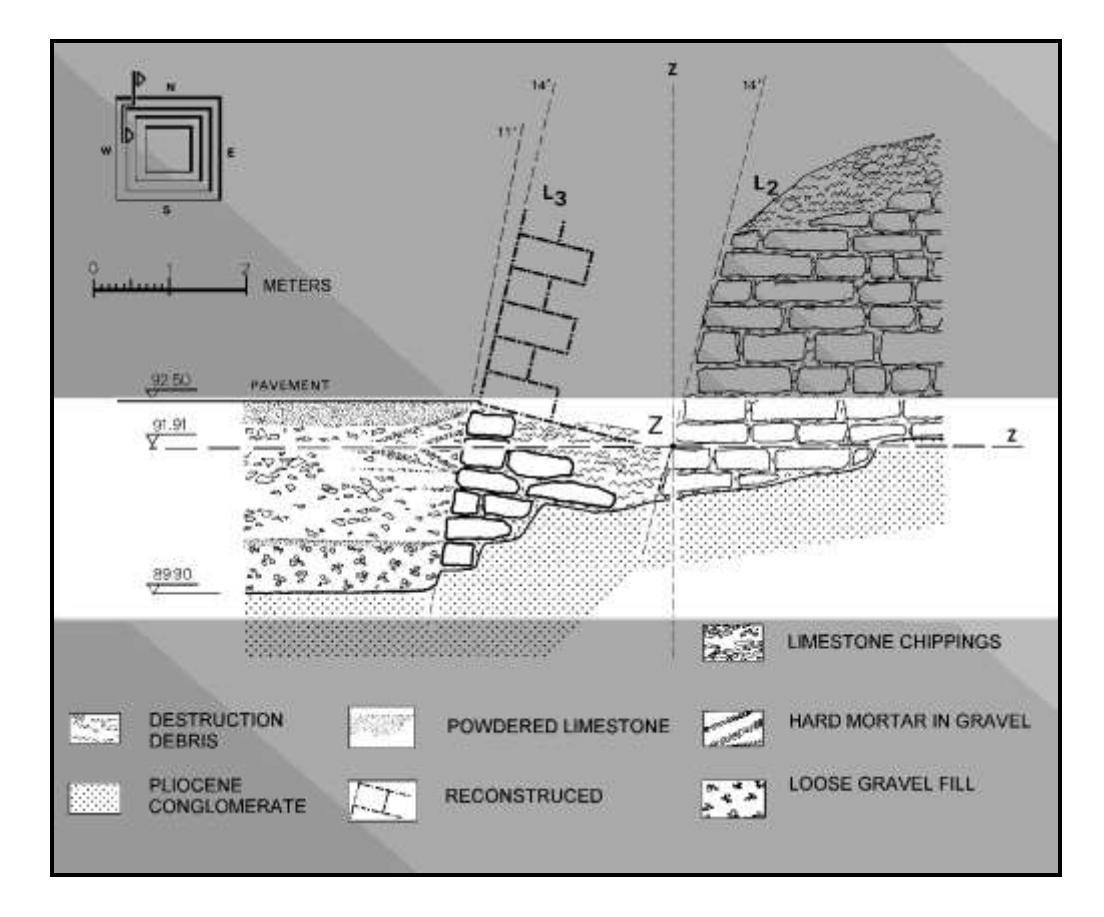
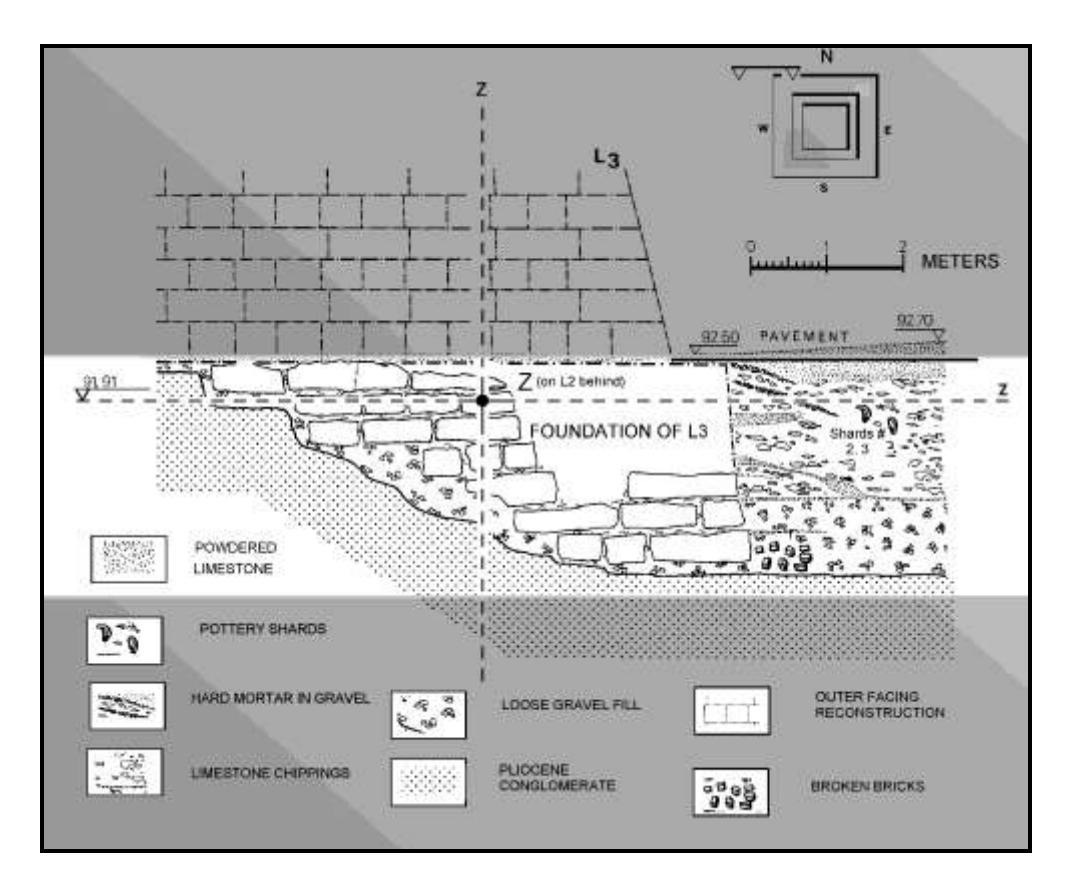
Below the pavement level on the unlevelled conglomerate at Seila

At Seila we have consider the buildings beneath the pavement level, and conglomerate terraces above it to be foundations. The nucleus corners were built at different levels on the original conglomerate surface; it was partly worked but not completely levelled. The inner parts were built on carefully stepped levels in the conglomerate.

The lower courses of some layers do not run from corner to corner, but are continued by the worked Pliocene conglomerate terrace, see elevations.

The foundation of the outer facing at Seila was built on levelled steps dug into the sloping conglomerate rock. Courses of masonry were built to extend the shorter steps and reach an all round level for the outer facing to be set. The pavement was constructed at that level.

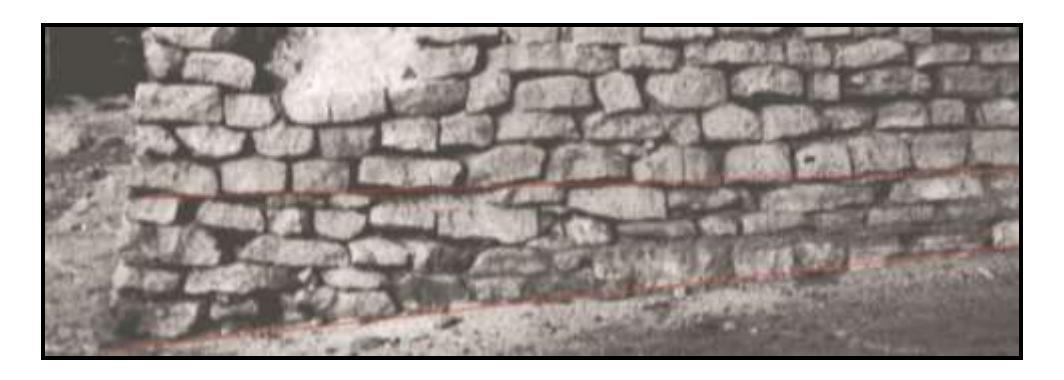
Below the pavement level on the unlevelled bed rock at el Kula

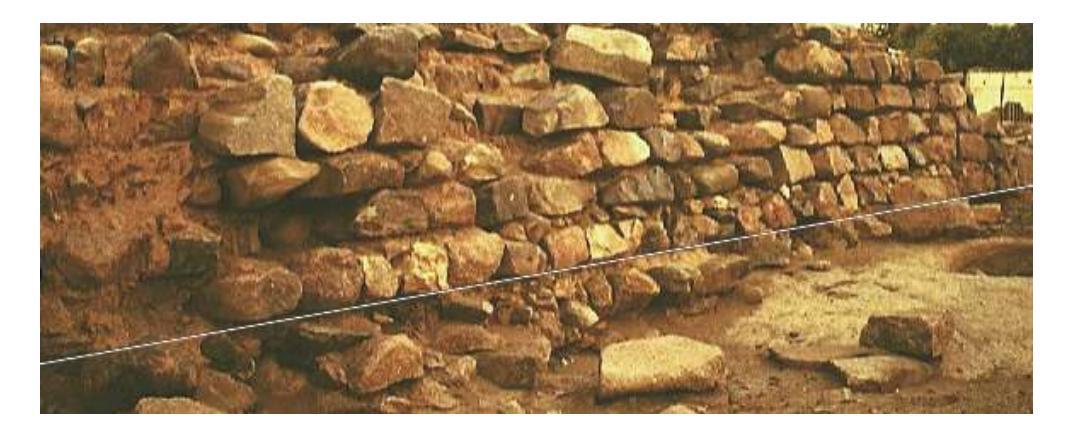
Below the pavement level on the unlevelled bed rock at Elephantine

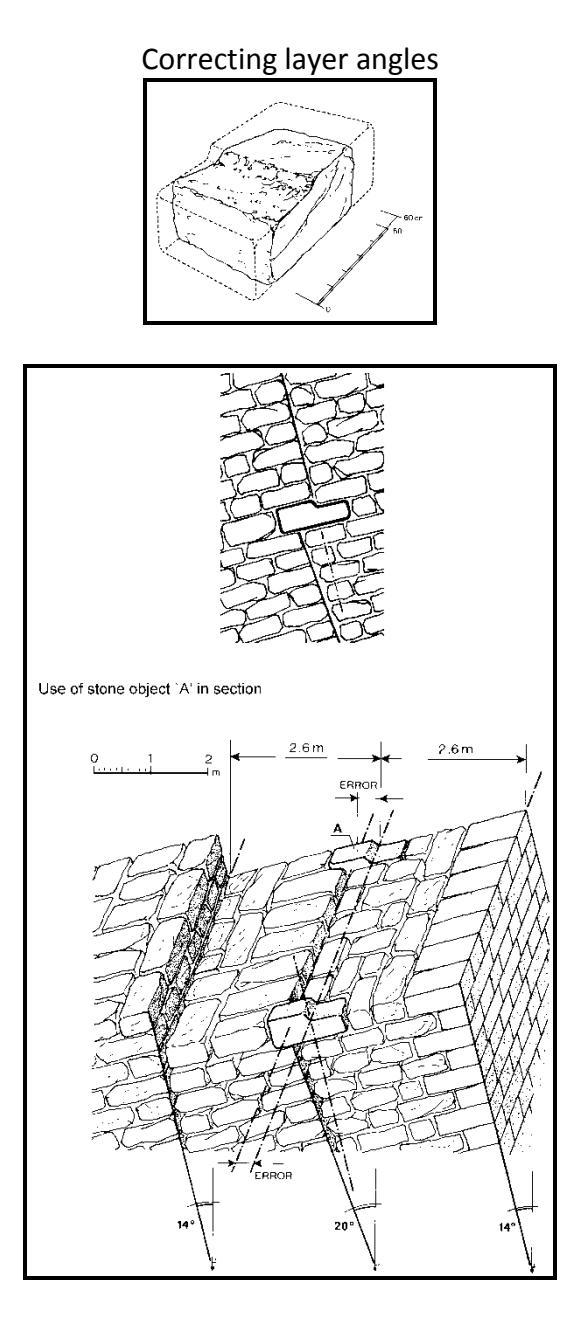
At the SW side near the west corner of layer 1, an elongated block projects out of it into layer 2. It looks as if the builders were aware of an increasing error of their plan. This was a reminder of how far back the face of layer 1 was receding. This block tells us also that there is a sequence of building the layers outwards

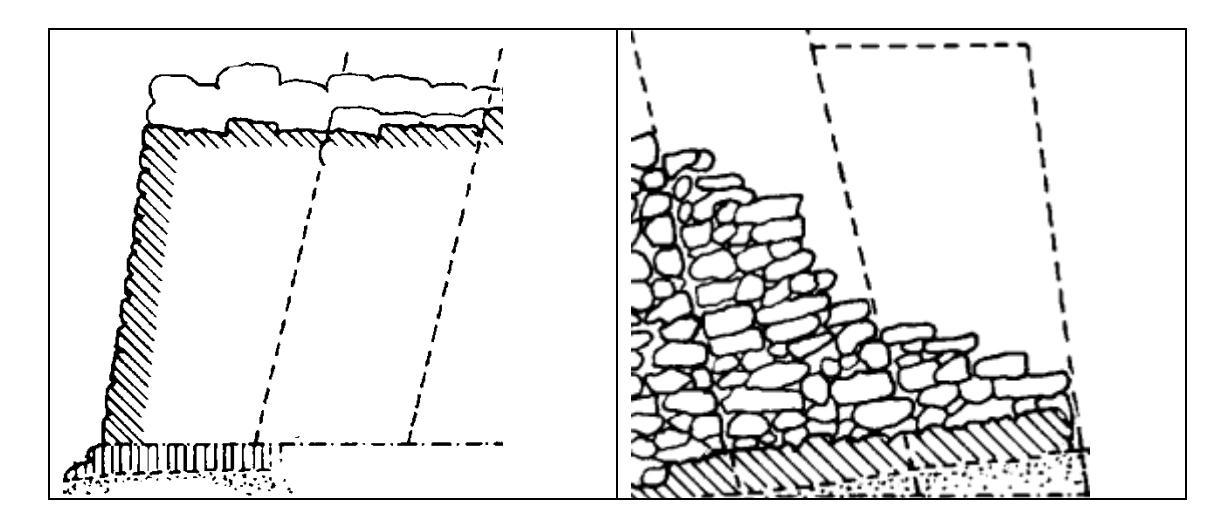
At Elephantine layer 2 grows thicker as the building rises to reach a correct side angle

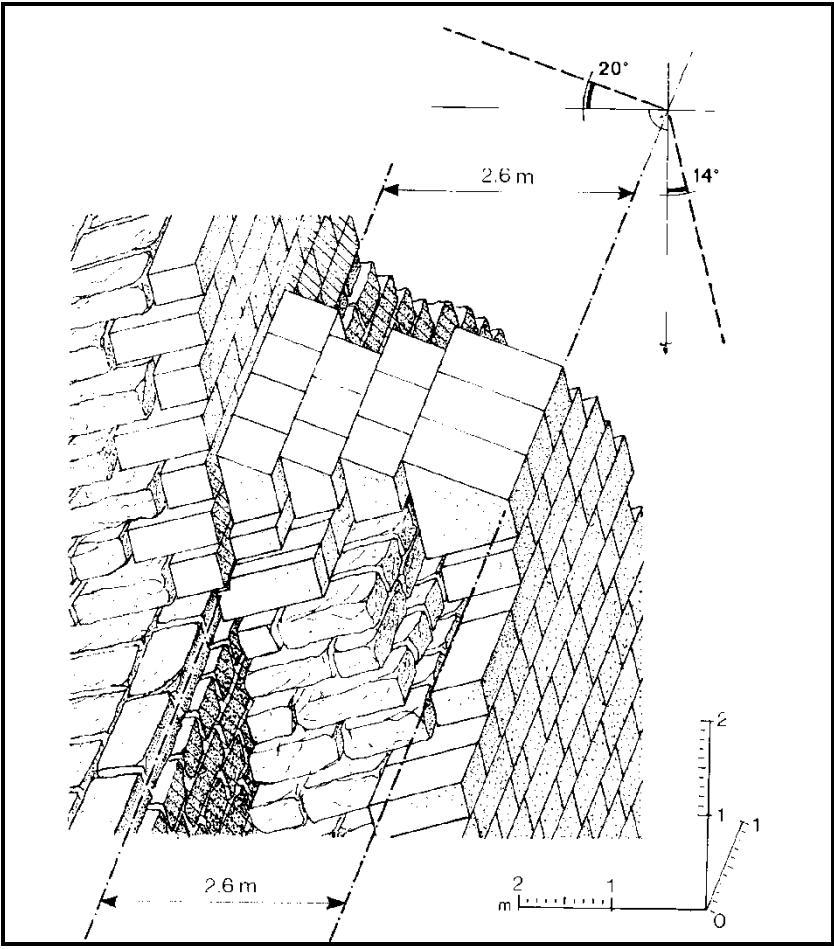
Axonometric drawing showing the point from which the height of a step is measured at Seila

At the layer monument of Seila another interesting stone object 'C' fig. 16c, suggests a method of fixing a point from which measurements of upper constructions were made. The block presents a curious horizontal cut at one end and remains of mortar on the surface. This mortar is of the same thin white constitution as that on the backing blocks found in situ on the north, east and south sides. This evidence tells us that stone object 'C' was used was used in the outer facing or something similar. I suggested that the inner corner of the cut was a point from which: The horizontal width of the step was measured.

And from which the vertical height of the next step, or construction, was measured. In the two options for reconstructing the layer monument of Seila in fig. 21a and 21b stone object `C' is built in L2. The position however is different because:

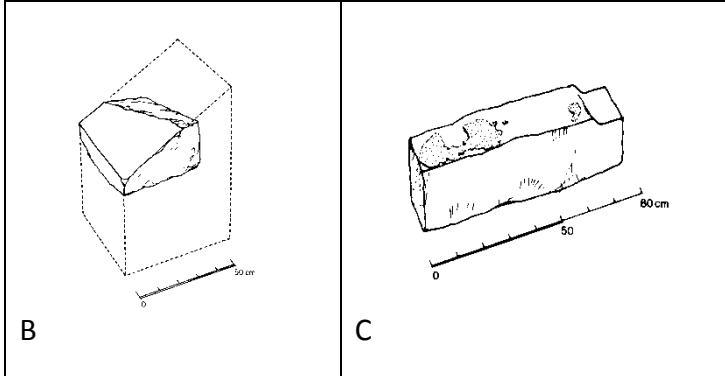
Stone objects of the outer facing at Seila.

This is an important fragment of an outer facing block from the edge of a step or one of the steps of the monument. It was found on the north side in the rubble above the spalls. It measures approximately 50X40X25cm and maintains two well-cut sides and two dressed faces at an angle 125° to 130° from each other.

This stone object was found in the rubble of the destruction above the limestone spalls on the north side. It is a fragment measuring 80x25x15 cm. with an angle cut along the 15-cm. edge. Remains of gypsum mortar are seen on the upper side. Probably used as an initial point for measuring the width of the step of one layer and the height of the step above.

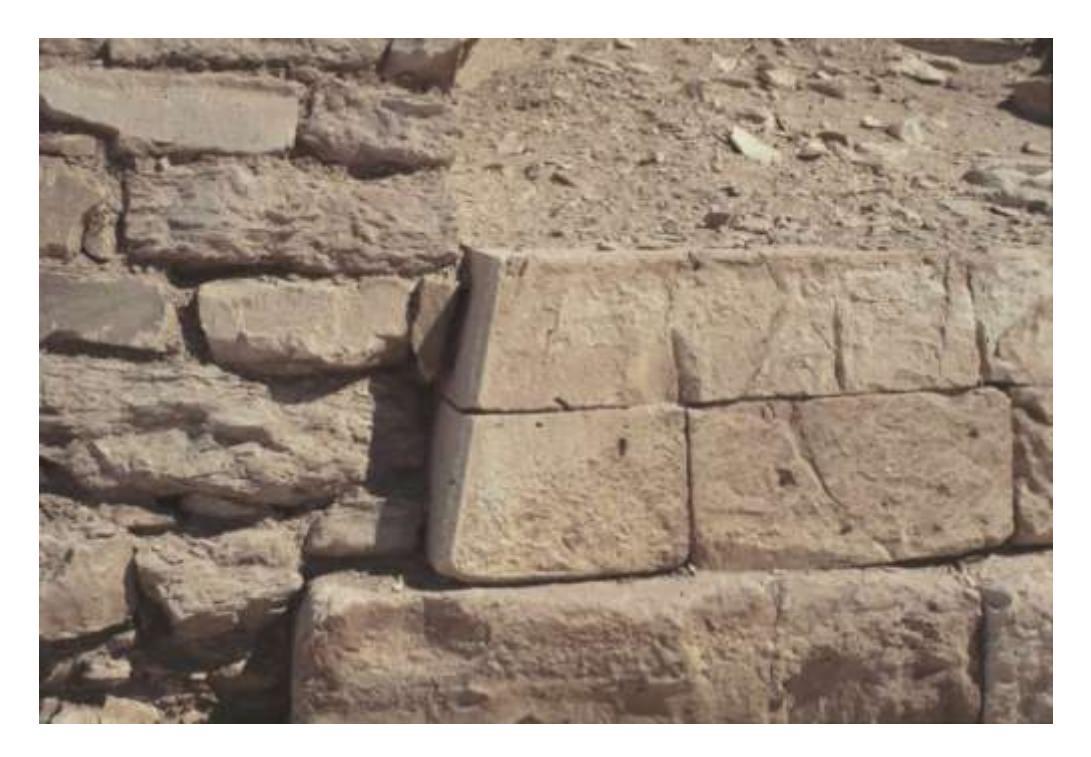
The foundation of the outer facing of the initial mastaba of the step pyramid aqt Saqqara

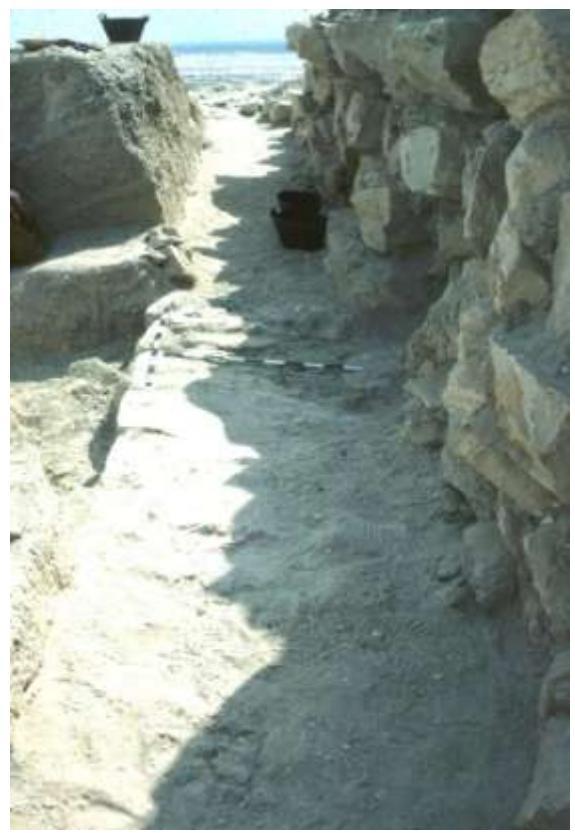
The foundation of the outer facing at Seila

At Seila the foundation of the outer facing was the uppermost course built on levelled steps in the sloping conglomerate rock. The facing blocks have been removed exposing the backing blocks seen to the right.

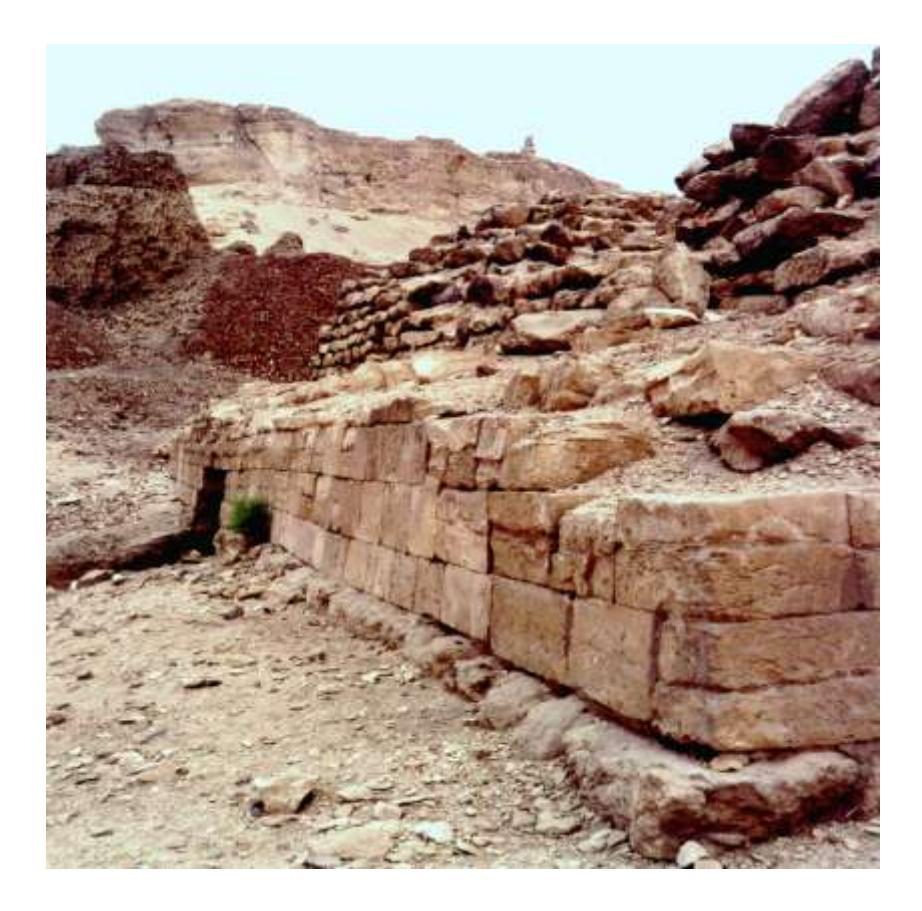
The foundation of the outer facing at Hebenu

At Hebenu 2 courses of rough masonry were set as a foundation for the fine limestone outer facing. This pit is on the north side resulting in the destruction of the foundation, exposing the backing blocks and the falling of the facing blocks.

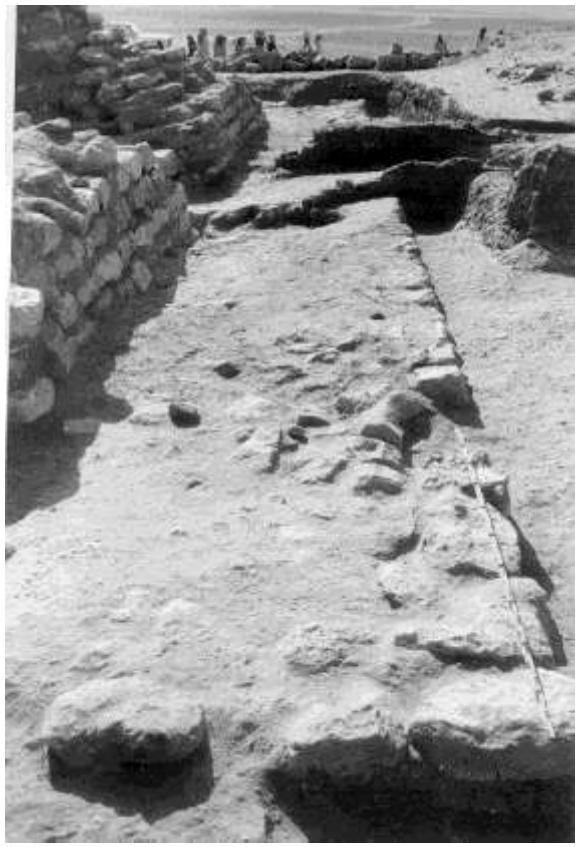
The foundation of the outer facing at Sinki

At Sinki the foundation of the outer facing at the north corner it surrounded the monument see figure /5

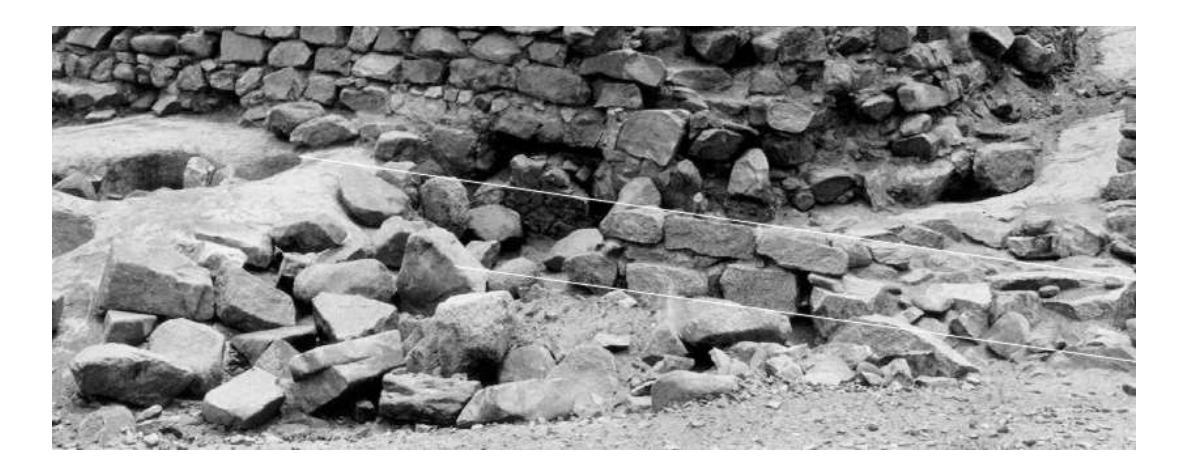
The foundation of the Outer facing at Elephantine

its nucleus would be necessary. Evidence of such a foundation was constructed around and extended under the nucleus. At Elephantine remains of the foundation of the outer facing are badly preserved; 2 courses can be seen in the foreground at the north east corner. The foundation extends under the nucleus

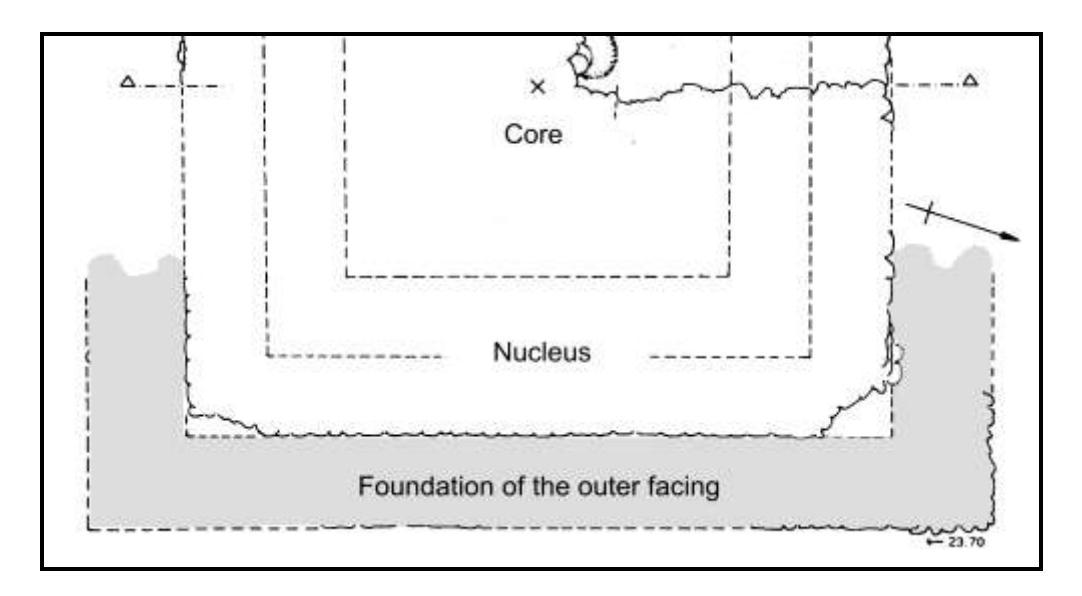
The plan of the foundation of the Outer facing at Elephantine

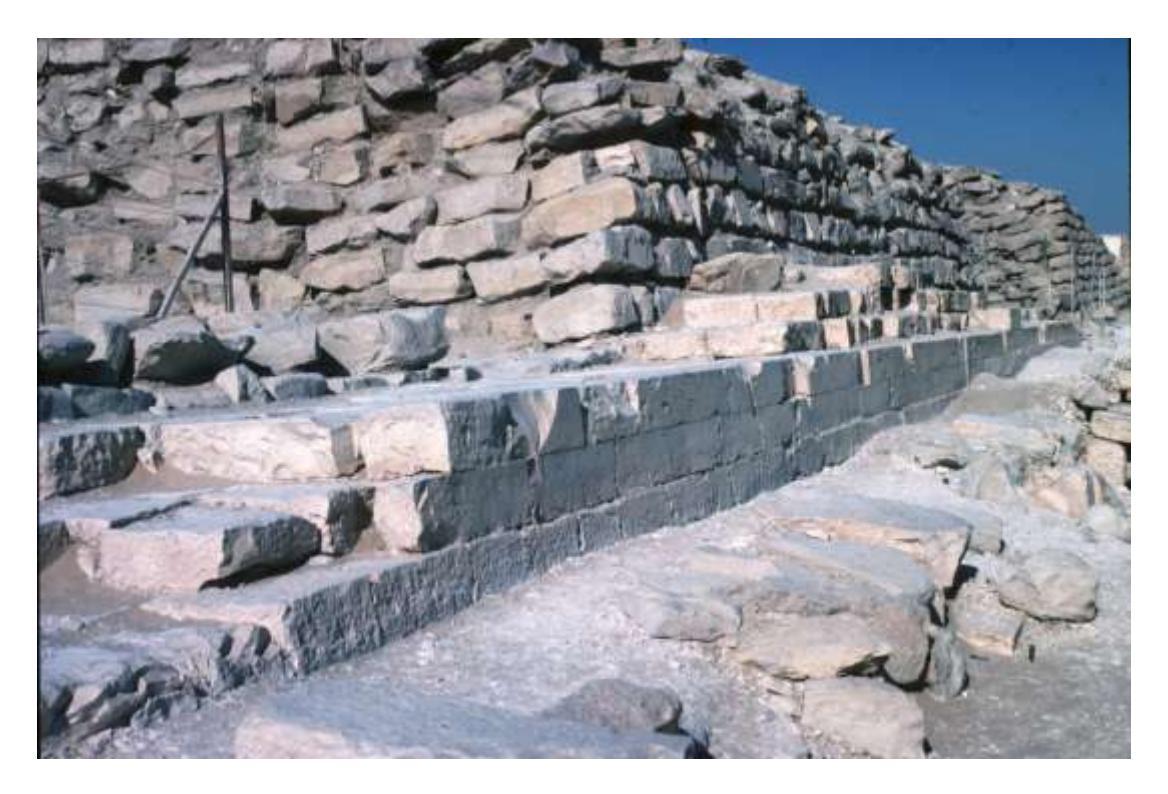
Outer facing of the southern tom of the step pyramid complex

The backing blocks of the outer facing were built with a few kinds of mortar hitherto noticed: Mousterian beach silt, tafl (clay) mortar, and thick chunks of a harder mortar found in the rubble.

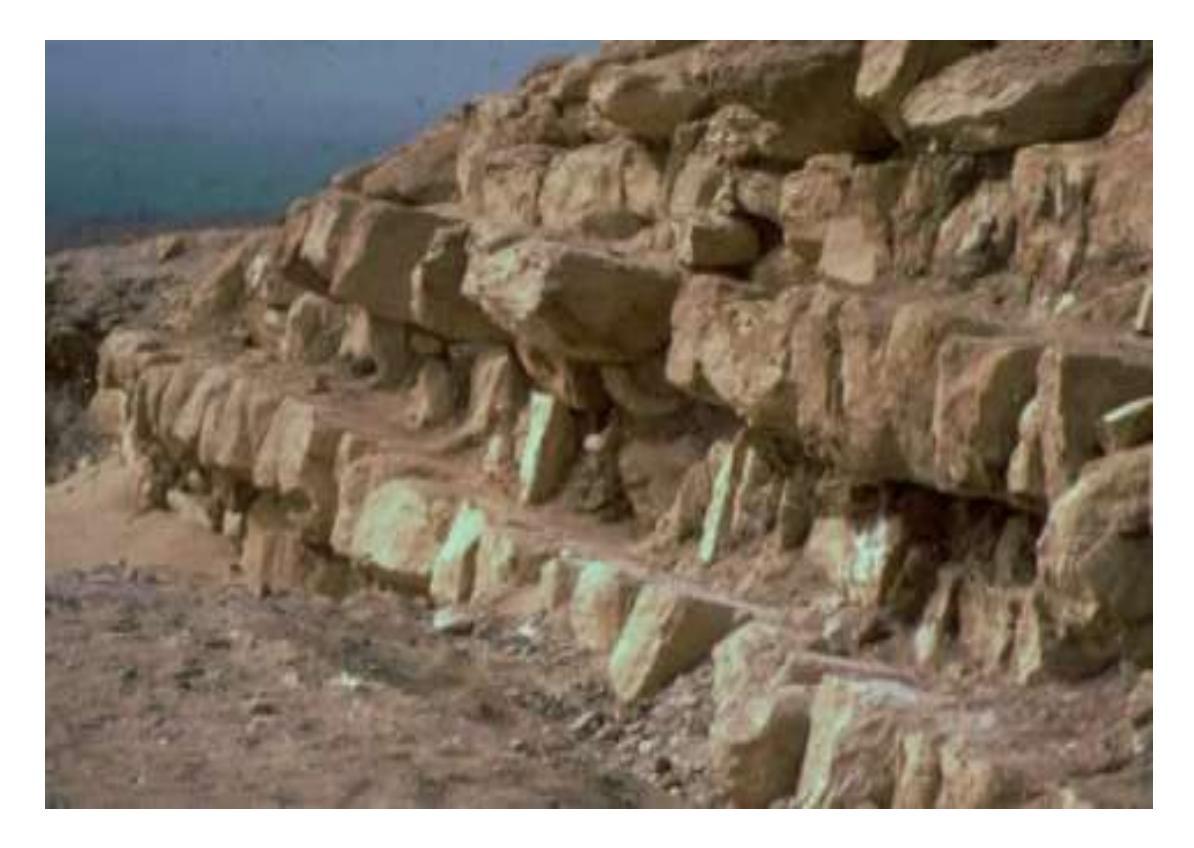
Backing blocks at Seila, the projecting courses back the stretchers while the receding courses back the herders

All the outer facing blocks were removed, and only backing blocks were in situ. Special care was paid to the method by which they were arranged creating a nice smooth level bedding for the outer facing. They were laid like brick in headers which were projecting and stretchers which were receding.

The header courses backed stretcher outer facing courses and the stretcher courses backed header outer facing courses and they were of a cubical form and their visible end was dressed.

At Seila the projecting courses backed outer facing stretchers and the receding courses backed the outer facing headers

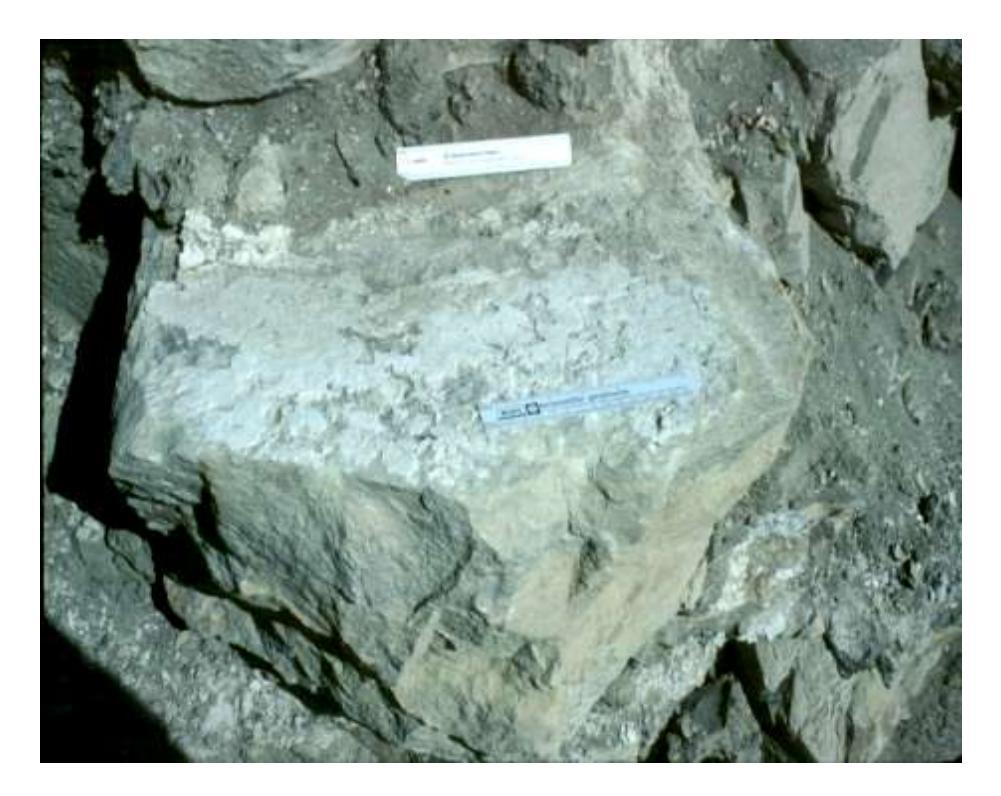
Gypsum on a backing block which fixes the outer facing blocks at Seila

At Seila a projecting backing block with traces of hard white gypsum on which an outer facing stretcher block was fixed

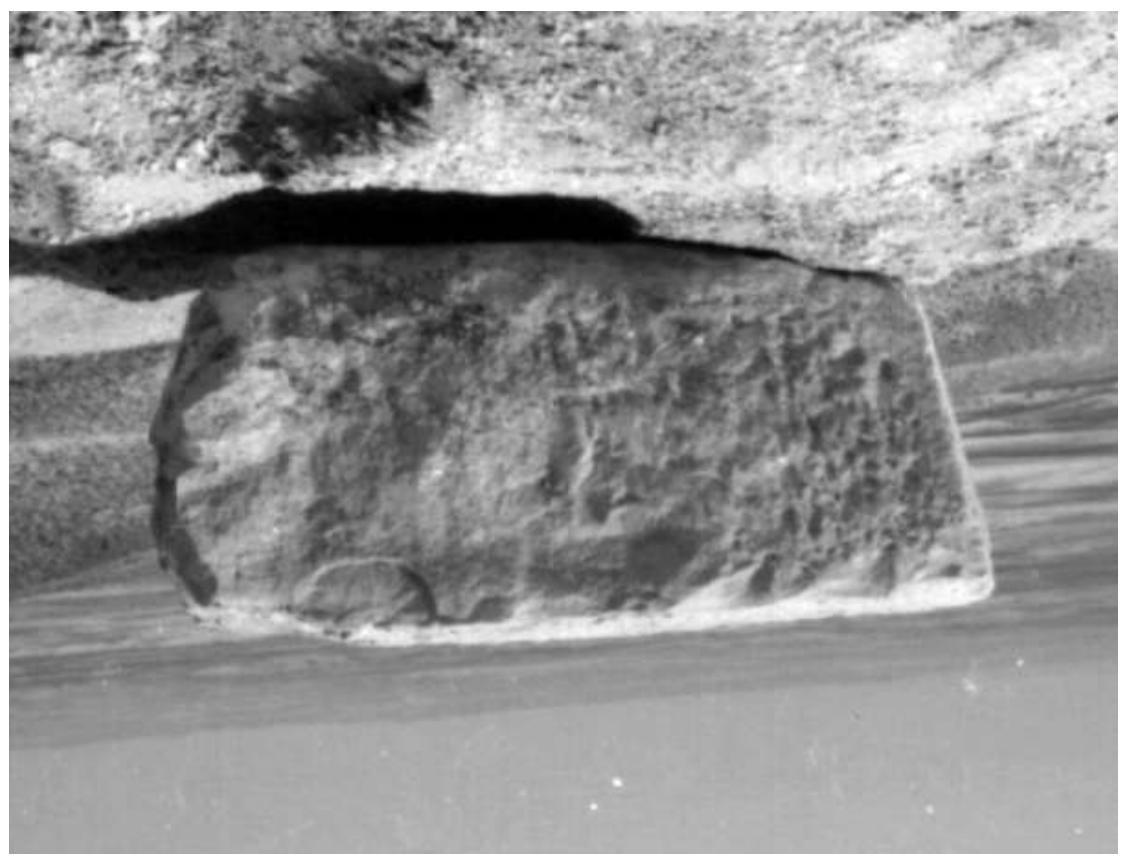
Outer facing header block at Seila

An outer facing, header and stretcher were buried in the spalls. A number of outer facing blocks found in the limestone spalls on the north and east sides see the principal plan this example of a header facing block.

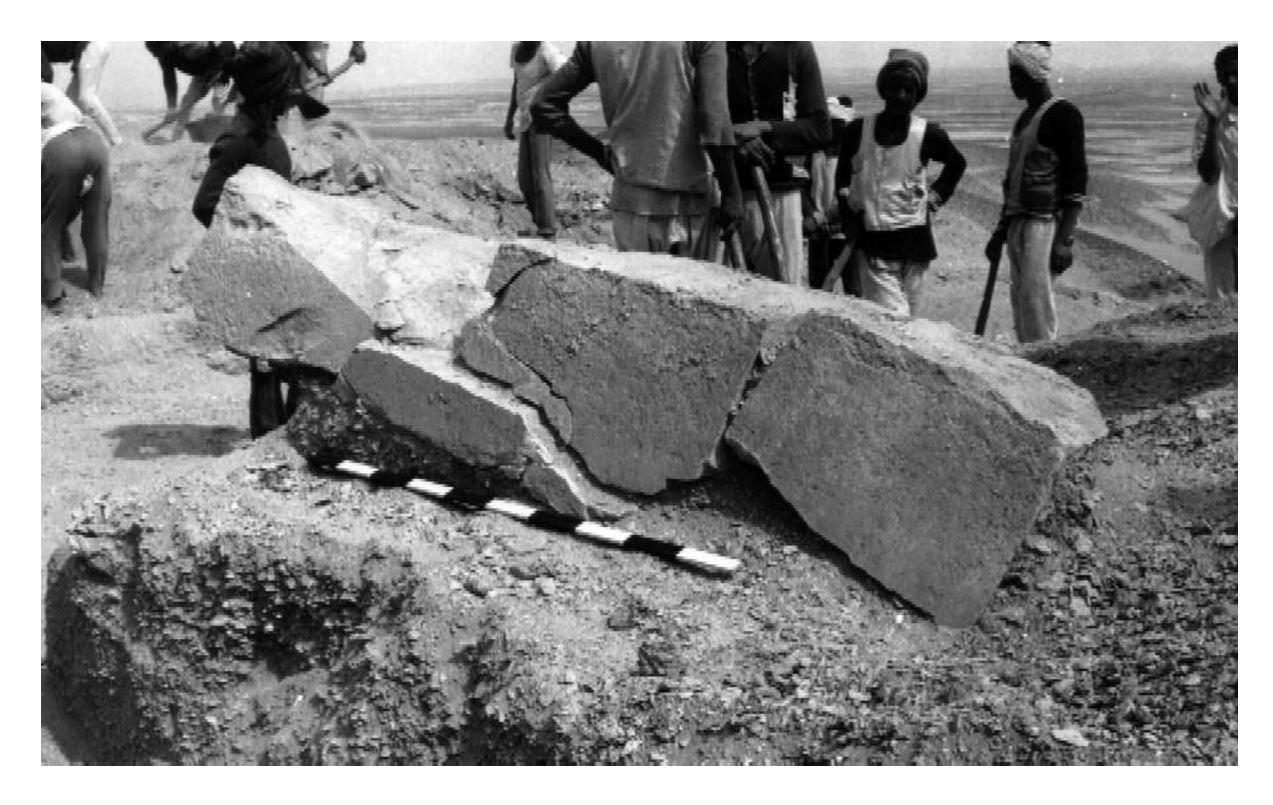
Outer facing stretcher block at Seila

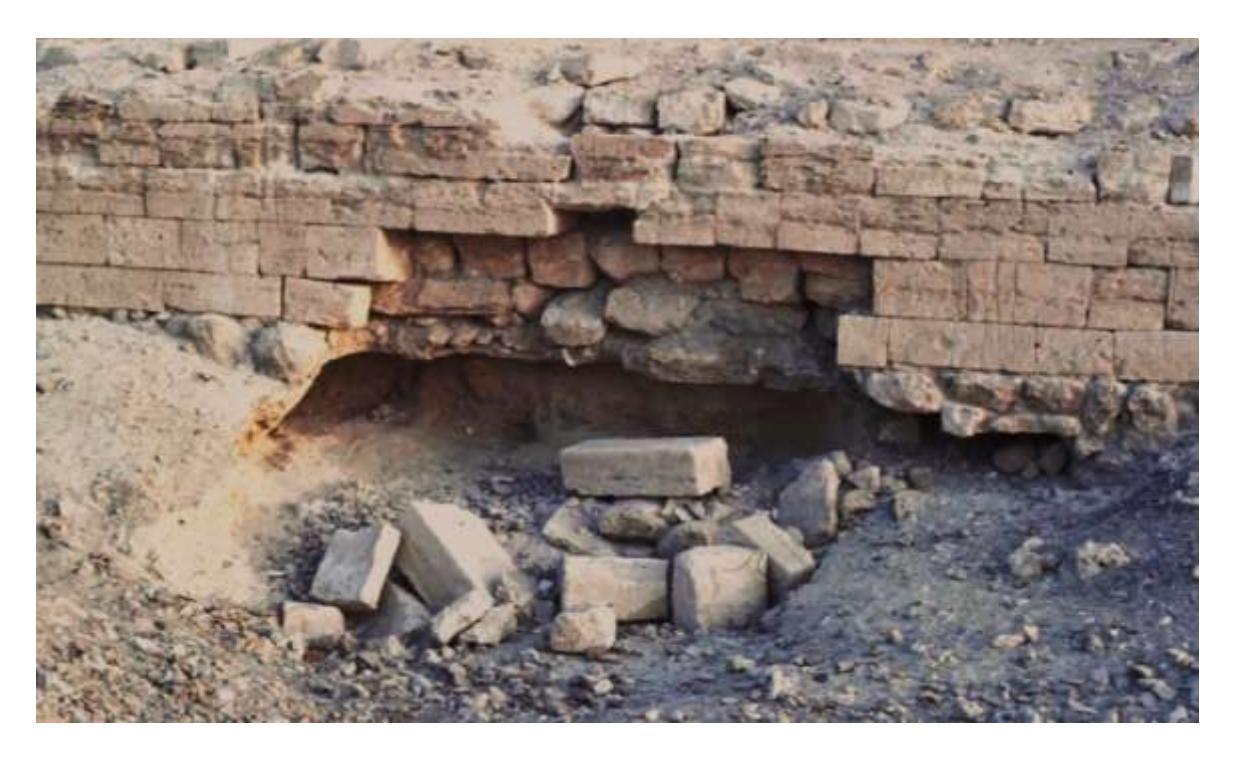
Outer facing at Hebenu north side; note 2 courses of the foundation

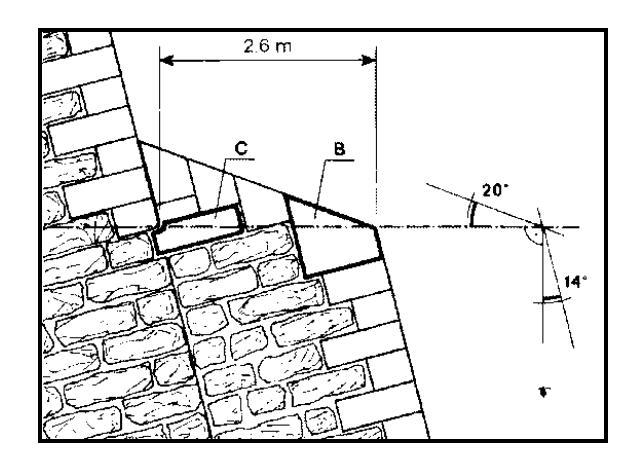
At Seila, stone objects B and C show the appearance of the step at Seila; this can apply to the benben option

At the layer monument of Seila stone object 'B' fig. 16b displays dressed surfaces and angles of basic importance to the slope of the step or steps of the layer monument. Fig. 19, 21a, 21b illustrate how I suggest the appearance of the step or steps at the layer monument of Seila appeared to be.

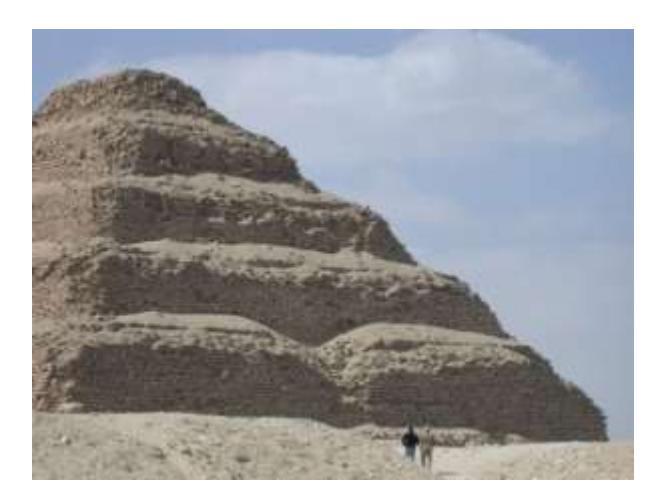
Sloping steps at the step pyramid

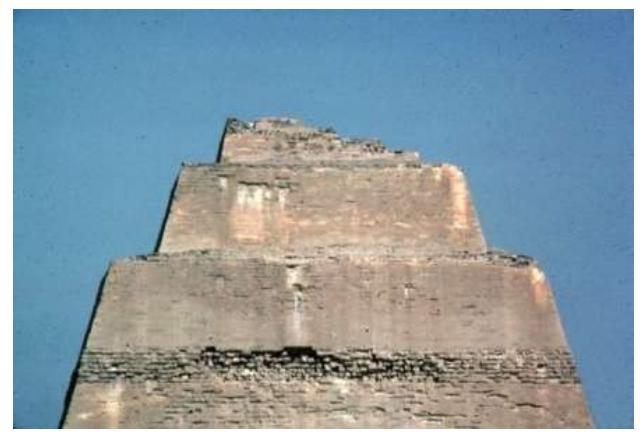
Flat steps at Meidum
